## EVALUATION OF LEVEL OF NON – MOTORIZED TRANSPORT (NMT) INFRASTRUCTURE ACCESSIBILITY, SAFETY AND ENVIRONMENT ON SELECTED ROADS IN KAMPALA CITY – UGANDA

Joel Mubiru<sup>\*1</sup>, Lawrence Muhwezi<sup>2</sup> and Rodgers. B. Mugume<sup>3</sup>

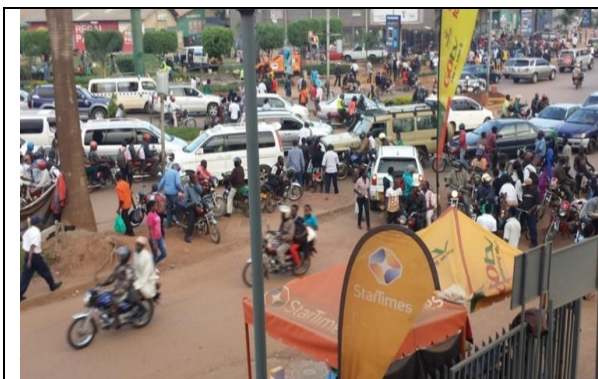
Furthermore, the lack of appropriate infrastructure, poor crossing facilities and the presence of obstructions along the roads often forces pedestrians to walk on the carriageway, which makes them even more vulnerable to accidents. On roads where there are no raised walkways like Kisenyi road and Sir Apollo Kagwa Road (Fig.2), pedestrians have to walk on the road shoulders, making them vulnerable to other road users who often use the same shoulders as well, especially “bodabodas” and pedal cyclists.

**Figure 1: Traffic Mix at Shoprite Road Junction**

Kampala experiences a comparably high motorization rate. Of the 80,000 vehicles registered countrywide (excluding motorcycles), over 60% are concentrated in Kampala which only covers 0.083% of the total land area in Uganda. The vehicle ownership is estimated to be about 15 cars for every 100 people which is far higher than the country's average of 2.4 per 100 people.<sup>[1,2]</sup> This makes it hard for pedestrians to use the road space due to a number of hindrances such as; high traffic jams during peak hours; high levels of traffic mix and sharing of road space between cars, pedestrians and “Bodabodas” (Fig.1) hence making the walkways inaccessible and unsafe.

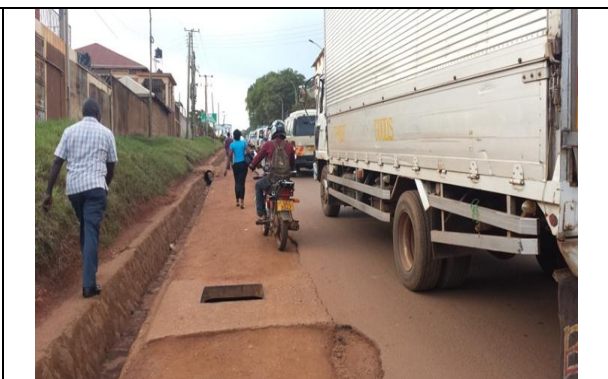
**Figure 2: Pedestrian walking across an open drain along Sir Apollo Kagwa Road**

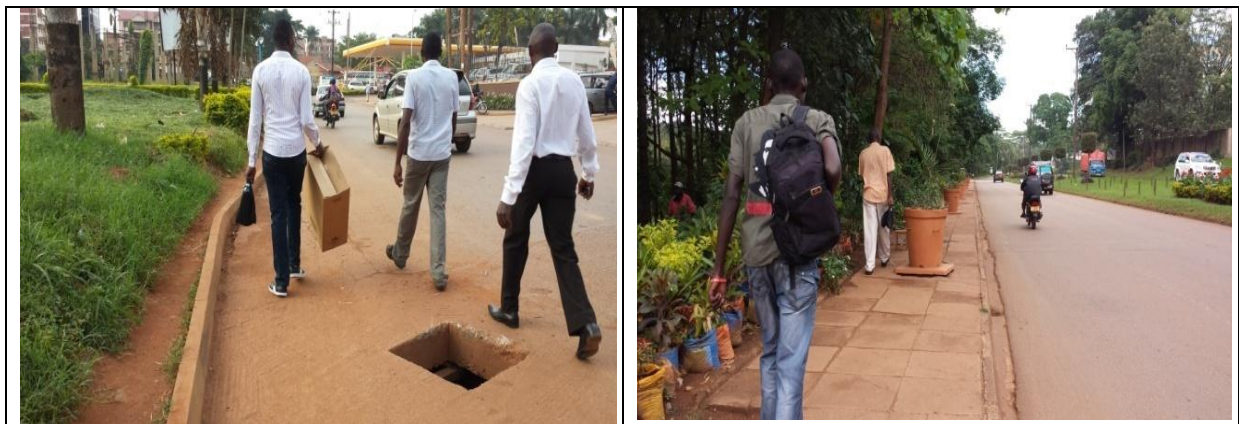
Another challenge of walking at night are attacks from thugs and pickpockets on the streets, especially when it is dark. Lastly open manholes that are not attended to have also left a number of pedestrians injured (Fig.3). Though KCCA has tried a number of times to close them, manhole covers have always been stolen. KCCA has now come up with an innovative way of covering manholes though by use of concrete flower pots though this technique compromises on the space of the walkways.

**Figure 3: Risky open manhole along Luthuli Avenue and flower pots along Yusuf Lule Road.**

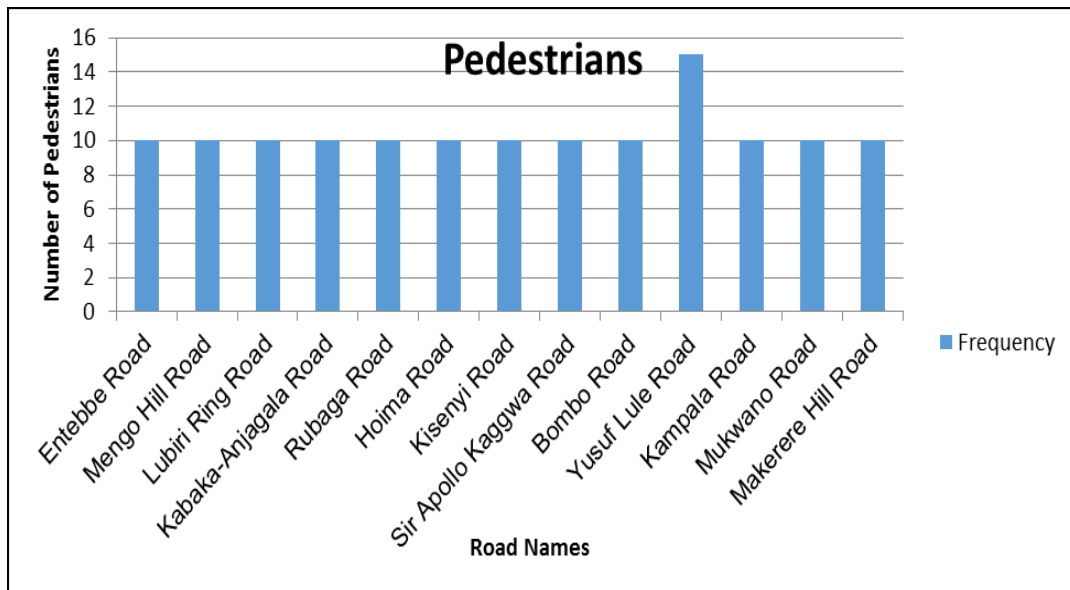
A total of 135 pedestrians responded to questionnaires served to them along 13 roads as summarised in Figure 4. Out of the 135 respondents, 94 (69.6%) were male and 41 (30.4%) were female. In the five age groups, the respondents within the age of 18 to 25 years had the highest number of respondents (37.8%) and closely followed by the age group of 26 to 35 years (36.3%). This was later followed by the 36 - 55 years group with 20% respondents. Pedestrians below 18 years and those above 55 years had the least percentages of respondents as shown in Table 1. With the percentage of respondents of the age below 18 being as low as 3.7%, the reasons and ideas given by the respondents were considered to be genuine and mature in nature making it reliable and significant.

**Figure 4: Number of Pedestrian Respondents.**
